Assessment of Proper Bonding Methods and Mechanical Characterization FPGA CQFPs

Milton Davis (NASA/GSFC)

CQFP Lead Fracture

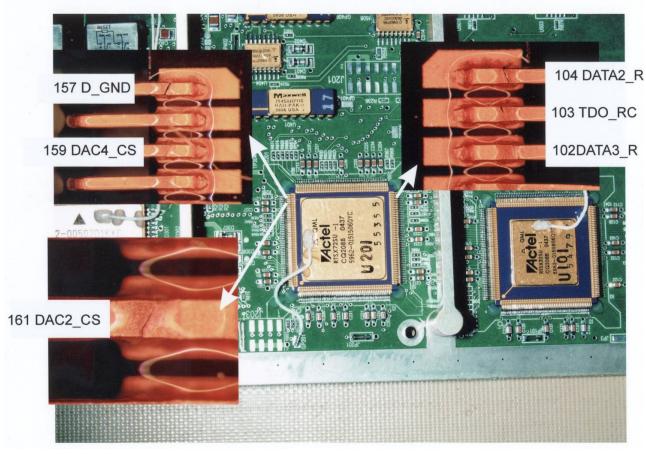
ACE A RWIC Failed ACTEL Pin Map

- After disassembling the ACE configuration, photographs showed six leads cracked on FPGA RTSX72SU-1 CQ208B package located on the RWIC card
- An identical package (FPGA RTSX32SU-1 CQ208B) mounted on the RWIC did not result in cracked pins due to vibration.
- The ETU was successfully qualified to through thermal and vibration test at qualification levels (14.1 GRMS, 2 min per axis, while the flight was taken to proto-flight levels (10 GRMS, 1 min per axis).

Figure - Six cracked leads on ACTEL FPGA 72SU CQFP during last axis of flight vibration

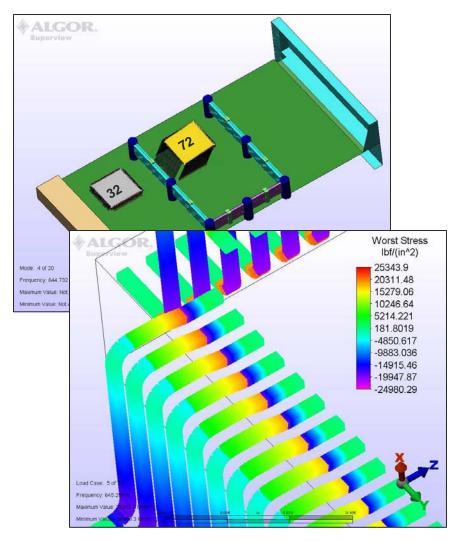
FEM Analysis

- Model built with composite plates, solids, and beams
- Modal and random vibe analysis performed prior to testing:
 - $\begin{array}{c} \circ & \text{Characterize} \\ & \text{mechanical behavior} \\ & (f_N, \, \sigma_{\text{Lead}} \, \text{vs} \, \sigma_{\text{Ult}} \, \& \\ & \sigma_{\text{Fatigue})} \end{array}$
- Results correlate with test results

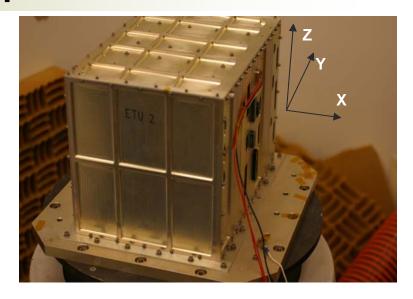
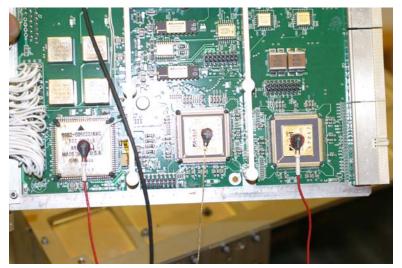
Test Setup and Inputs

- Sine sweep test: ¼ g from 20 to 2400 Hz at 4 octs/min on Z and Y (// and ⊥ to PCB respectively)
- Accelerometers placed on board, chassis and parts to monitor results with varying bond methods
 - No interstitial material
 - Mimicking the flight build only a corner bond (Arathane 5753)
 - Only an under-fill (Nusil CV-2942)
 - Only a corner bond (Epoxy 2216)
 - Mimicking the qualified build under-fill and corner bond (Arathane 5753 or Epoxy 2216 Gray)

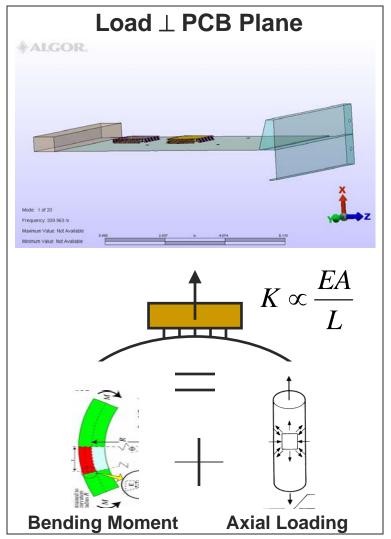
Component Response Due to Out-of-plane Loading (Axial)

Frequency Response [Hz] as Function of Bonding							
		No	Uralane	Nusil CV-2942	Epoxy 2216 Corner Bond				
		Bonding	Corner-bond	Under-fill					
k g	Board Flexure								
Axial & Bending	Test Results	Results 348							
۸xi	FEA Assembly	340	340	340	347				
/ B	Hand Calcs			325					
		72SL	J Motion						
0	Test Results	631							
kin	FEA Assembly	645	707	2821	3247				
Rocking	Hand Calcs	667	726	2539	3706				
	FEA Component	648	709	2838	3828				
ng	Test Results	~880							
Twisting	FEA Assembly	905	1022	1913.6					
<i>≶</i> ⊢	FEA Component	908	1026	1926.19	6350				
		32SL	Motion	-	-				
g	Test Results	1003							
kin	FEA Assembly	948	1074	3340	>3247				
Rocking	Hand Calcs	1106	1170	3368	4965				
	FEA Component	952	1079	3431					
ng	Test Results	~1350							
Twisting	FEA Assembly	1339	1565	2435	>3247				
<i>≫</i> ⊢	FEA Component	1344	1573	2443	6555

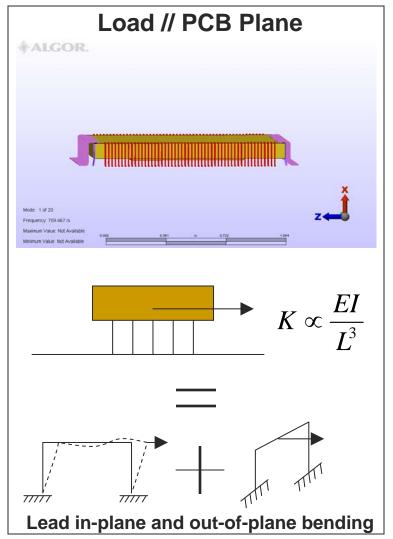
Component Response Due to Inplane Loading (Rocking)

Frequency Response [Hz] as Function of Bonding						
Component	Assessment	No	Uralane	Nusil CV-2942	Epoxy 2216			
Response	onse Method		Corner-bond	Under-fill	Corner Bond			
9 D	Board Flexure							
Axial & Bending	Test Results	348						
4xi ßen	FEA Assembly	340	340	340	347			
	Hand Calcs			325				
		72SL	J Motion					
g	Test Results	631						
kin	FEA Assembly	645	707	2821	3247			
Rocking	Hand Calcs	667	726	2539	3706			
	FEA Componen	648	709	2838	3828			
ng	Test Results	~880						
Twisting	FEA Assembly	905	1022	1913.6				
× –	FEA Component	908	1026	1935	6350			
		32SL	Motion	-	-			
g	Test Results	1003						
kin	FEA Assembly	948	1074	3340	>3247			
Rocking	Hand Calcs	1106	1170	3368	4965			
	FEA Componen	952	1079	3436				
Twisting	Test Results	~1350						
	FEA Assembly	1339	1565	2435	>3247			
<i>≶</i> ⊢	FEA Component	1344	1573	2443	6555

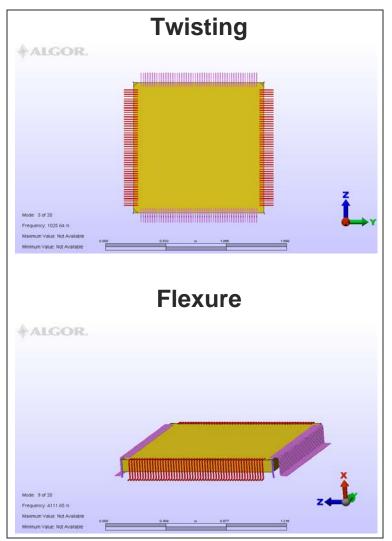
Component Response Due to Inplane Loading (Twisting)

Frequency Response [Hz] as Function of Bonding						
Component	Assessment	No	Uralane	Nusil CV-2942	Epoxy 2216		
Response	Method	Bonding	Corner-bond	Under-fill	Corner Bond		
~ D	Board Flexure						
al 8 din	Test Results			348			
Axial & Bending	FEA Assembly	340	340	340	347		
B	Hand Calcs			325			
		72SL	J Motion				
0	Test Results	631					
kin	FEA Assembly	645	707	2821	3247		
Rocking	Hand Calcs	667	726	2539	3706		
	FEA Component	648	709	2838	3828		
Twisting	Test Results	~880					
/ist	FEA Assembly	905	1022	1913.6			
	FEA Componen	908	1026	1935	6350		
		32SL	Motion				
	Test Results	1003					
kin	FEA Assembly	948	1074	3340	>3247		
Rocking	Hand Calcs	1106	1170	3368	4965		
	FEA Component	952	1079	3436			
ing	Test Results	~1350					
Twisting	FEA Assembly	1339	1565	2435	>3247		
<u> </u>	FEA Componen	1344	1573	2443	6555

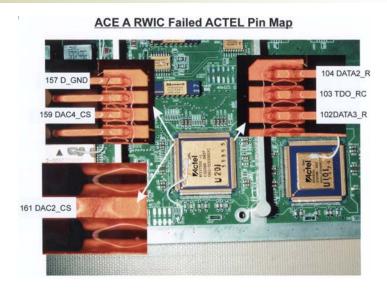
- No material defects in pin
- Pins fractured due to stress exceeding stress limitation
- Material analysis conveyed grain size of material is between 50 and 80 micrometers
- Location of fractured pins correlates well with location of highest stress from FEA

Figure - Mapping of the failed pins

Figure - Stress results from FEA due to loading // to PCB plane

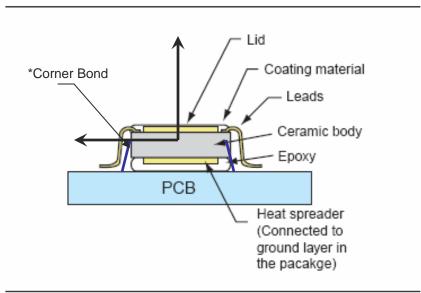
Figure 8 • Top Coating and Bottom Epoxy on CQ Package with Heat Sink on the Bottom

- ACTEL suggests following for CQ256 and CQ352:
 - No suggestion for material types
 - A non [electrically]
 conductive epoxy/glue
 applied between board
 and component base
 post solder to absorb
 energy during vibration
 - **Top (UV) cure for high stresses in braze area

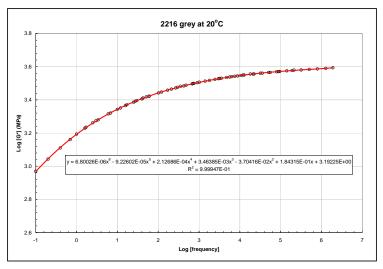
E as function of f _N for adhesives from DMA								
Material	1 Hz	1 Hz 640 Hz 1000 Hz 2000 Hz						
Nusil								
CV2942	30.6	40	40.8	42.1				
5753								
(14%								
Cabosil)	10.1	19.3	20.1	21.4				
2216								
Grey	1557	3125	3200	3308
